MEMO

TO:	Cottonwood Creek HOA Attn: Mr. John Grose, Mr. Neal Ferry
FROM:	Tim Jensen, P.E. Edward Schnackenberg, P.E.
RE:	Cottonwood Creek Pavement Evaluation
DATE:	May 31, 2019
OLSSON PROJECT #:	019-0664

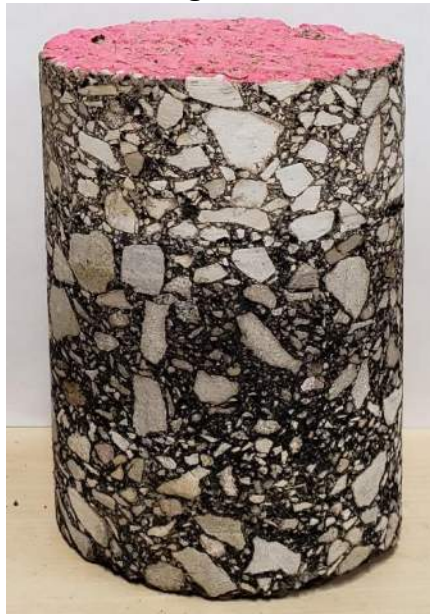
Figure 1

Table 1 below outlines the pavement thickness and existing subgrade conditions at each core location. Olsson rated the quality of the pavement cores on a scale of 1 thru 4, with "1" considered to be "good quality", competent asphalt pavement (Figure 1) and "4" being considered to be "heavily deteriorated" asphalt pavement (Figure 2).

Example: Core score of 1

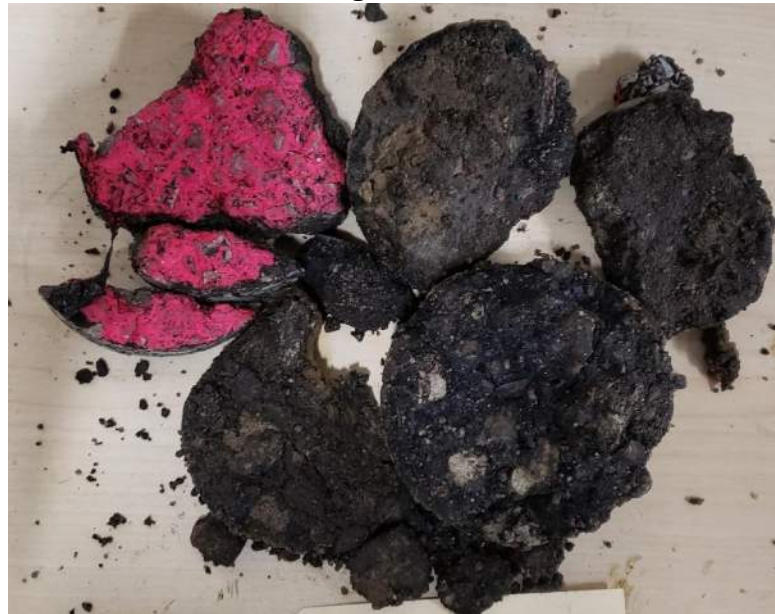
Figure 2

**Example: Core score of 4
(C-12)**

(C-19)

Boring B-19 was positioned in an area where the existing pavements were considered heavily deteriorated.

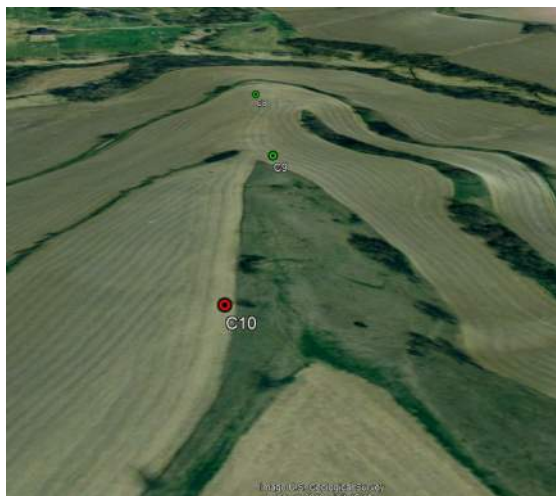
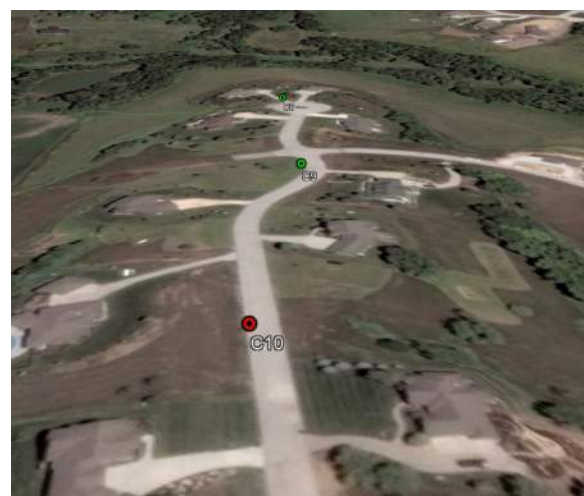
Borings B-9 and B-10 appear to have been positioned near an original natural terrain ridgeline. Visually, the pavements in these areas appear to be performing quite well under existing site conditions. Even with the slightly lower subgrade unit weights, the drainage improvements in these areas are still producing an adequate pavement section.

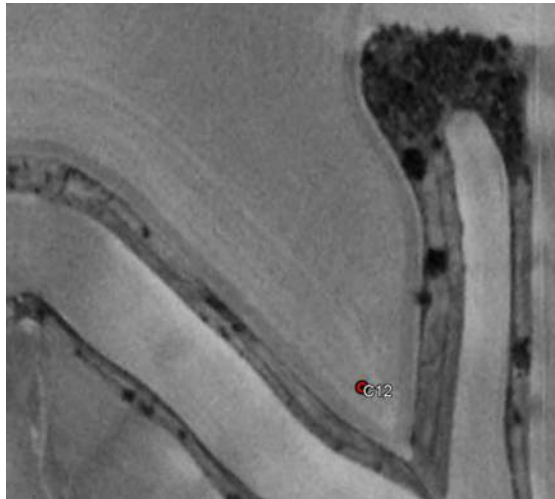
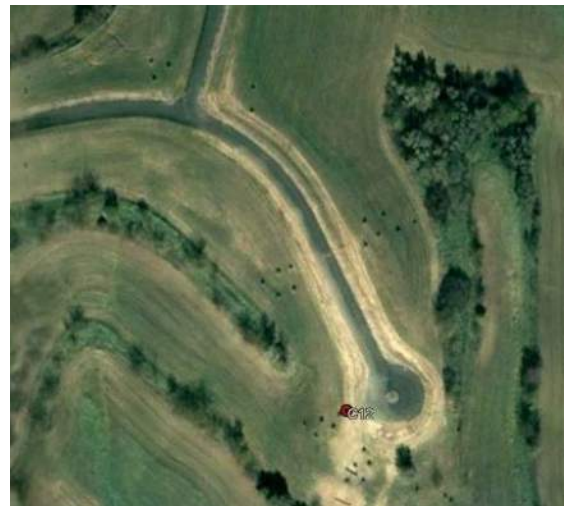
Boring B-12 appears to have been located in an area behind a previous agricultural terrace. Areas behind terraces are known for collecting surface runoff, sediment, and overtime the soils can become softer and experience increases in moisture contents.

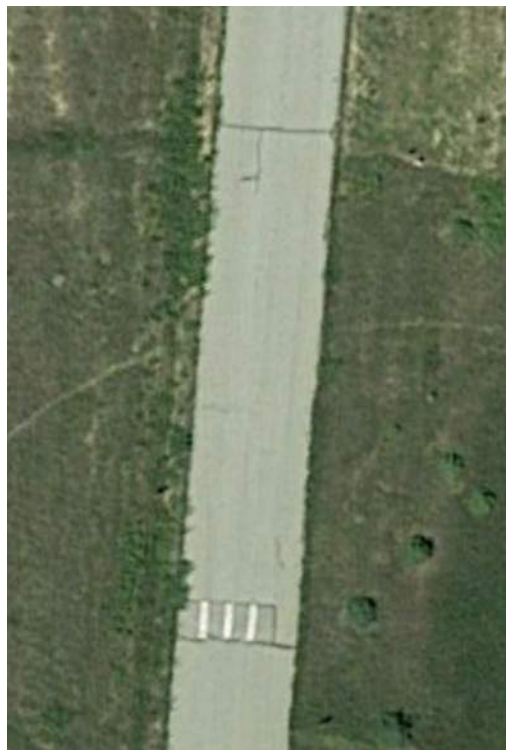
Most of the pavement cracks observed were transverse, or perpendicular to the road surface. These cracks are typically associated with shrinkage of the asphalt surface due to low temperatures and the asphalt binder hardening over time. These cracks can be large and allow significant moisture infiltration to the underlying subgrade soils creating differential movement and a rough driving surface that continues to deteriorate as the pavement damage increases over time. In the photo below, the surface moisture that collects in the transverse cracks is flowing toward the edges of the roadway where the water flow is restricted by the clay subgrade contributing to the increased pavement deterioration with time. If not repaired, the damaged pavement and softened subgrade area will continue to grow.

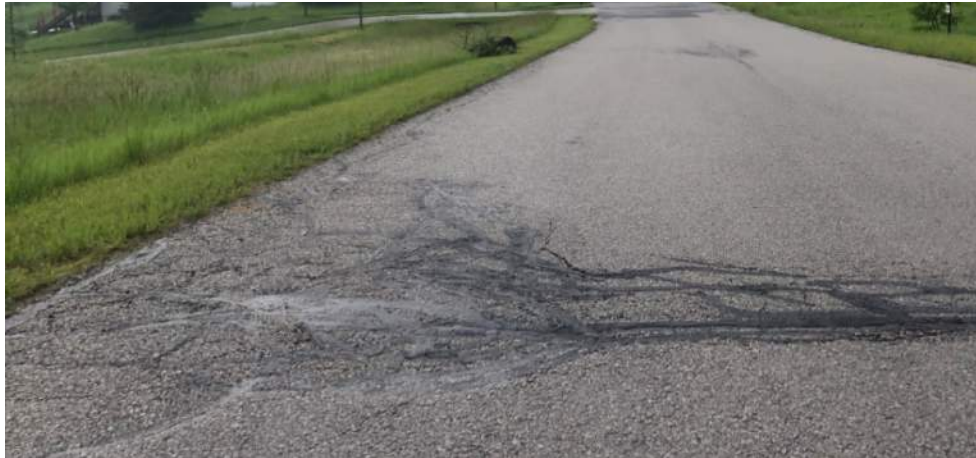
Since the existing roadway divides the natural side slope there is an increased potential for moisture from upgradient areas (east portions) to flow toward the west and southwest. Woodcrest Circle road may be restricting the westward movement of this moisture toward the creek. We recommend the roadside ditches be maintained at a minimum 5-foot width and kept free of sediment, silt, and debris to maintain adequate flow away from the road. After the drainage is improved, the HOA should consider completing isolated full depth pavement replacement where visible distress and pavement damage are most prevalent. Refer to the example photo below.

In general, Olsson observed about 15 (+/-) areas where isolated full depth pavement replacement or repairs should be considered. These pavement areas, near the south entrance, are primarily located around or near the existing transverse pavement cracks. We estimate about 250 linear feet of roadway would be applicable for this full depth pavement replacement. More information regarding full depth removal and replacement is provided later in this memo. Considering the fatigue that has been occurring below the pavement surface, between the south entrance and the intersection of Woodcrest Dr., an asphalt mill and overlay should be considered. We recommend a minimum milling and replacement depth of 2.5 inches be considered to remove the surface course, the disturbed asphalt layers, and to properly prepare the underlying surface for the new overlay. To provide a smooth uniform surface after the initial overlay is completed, a reduced mill and overlay thickness of 2.0 inches could be considered for the remaining roads within this development. After the initial milling operations are complete, the exposed asphalt surface should be inspected and reevaluated to determine if additional areas of deterioration or damage are observed and if additional removal and replacement may be necessary.

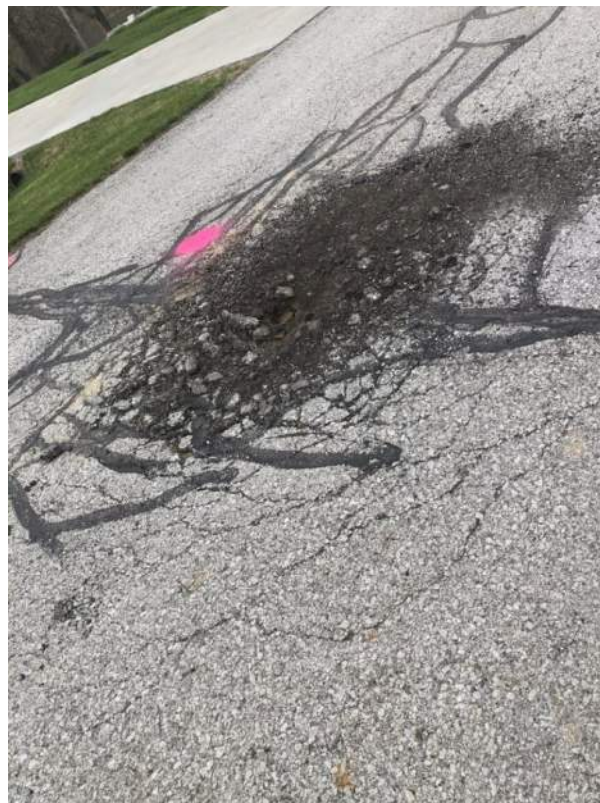
Considering the roadway at the base of natural side slope currently has a sag in it, there is an increased potential for moisture from upgradient areas to flow toward Cottonwood Creek Drive and Switchgrass Road near the entrance. In this area we also recommend the roadside ditches be graded and maintained at a minimum 5-foot depth and kept free of sediment, silt, and debris to provide suitable surface moisture flow away from the road. After the drainage is improved, the HOA should consider completing isolated full depth pavement replacement where visible distress and pavement damage are most prevalent.

In general, Olsson observed about 30 (+/-) areas where isolated full depth pavement replacement or repairs should be considered. These pavement areas are primarily located around or near the existing transverse pavement cracks. The pavements from the intersection of Cottonwood Creek Drive and Switchgrass Road extending north about 500 feet should be considered for an asphalt mill and overlay. We recommend a minimum milling and replacement depth of 2.5 inches be considered to remove the surface course, the disturbed asphalt layers, and to properly prepare the underlying surface for the new overlay. To provide a smooth uniform surface after the initial overlay is completed, a reduced mill and overlay thickness of 2.0 inches could be considered for the remaining roads within this development. After the initial milling operations are complete, the exposed asphalt surface should be inspected and reevaluated to determine if additional areas of deterioration or damage are observed and if additional removal and replacement may be necessary.

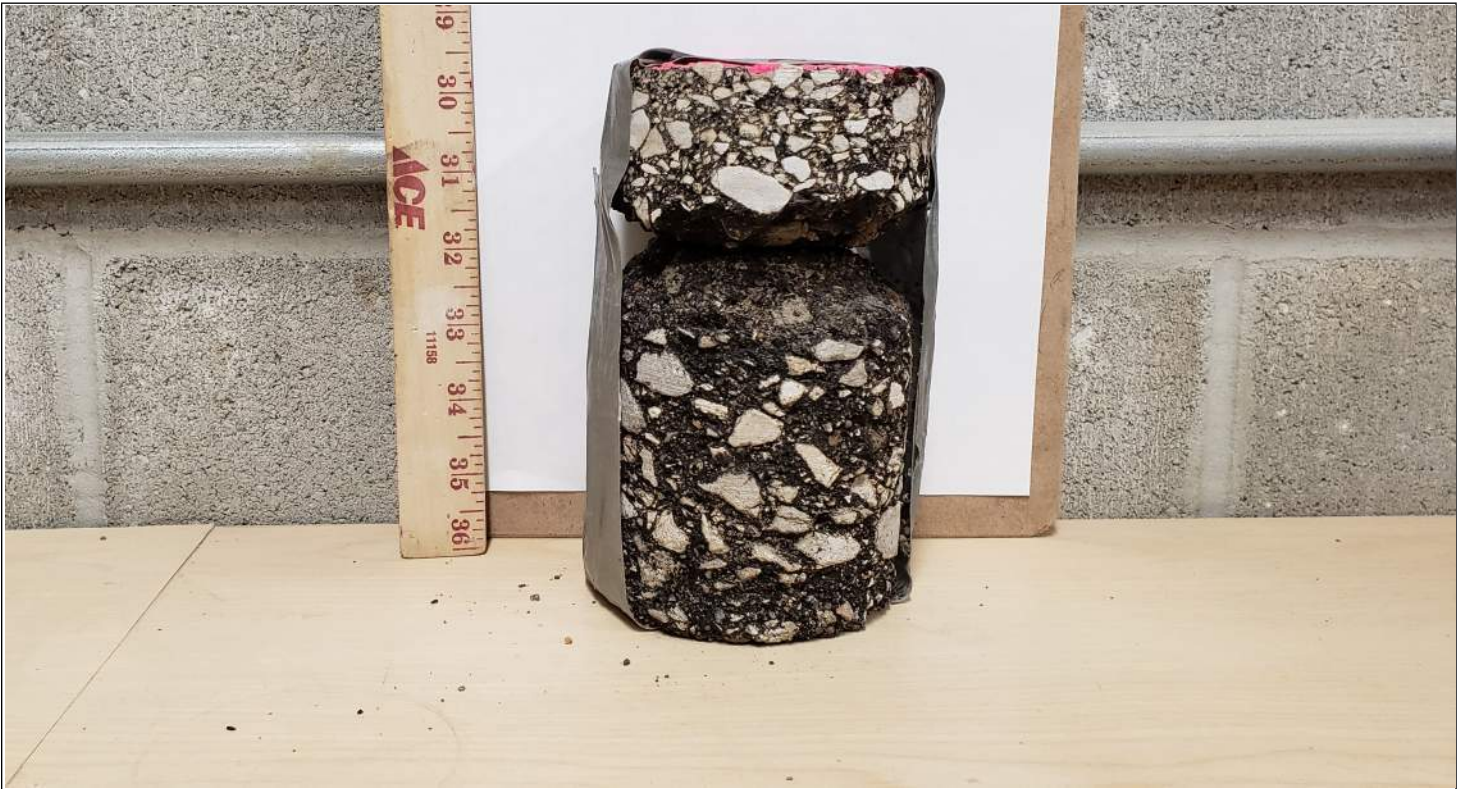
Description: C-3

The recovered pavement cores from Woodcrest Circle (C-3 through C-7) indicated excessive asphalt deterioration/delamination between the surface course and base course layers. Moisture is being trapped within the asphalt layers and the repetitive freeze/thaw action and traffic loading has accelerated the pavement deterioration. It should be noted that these cores were located in areas that did not yet have significant visible surface damage. Although these core locations were less disturbed at the surface, the asphalt quality below the surface has been compromised.

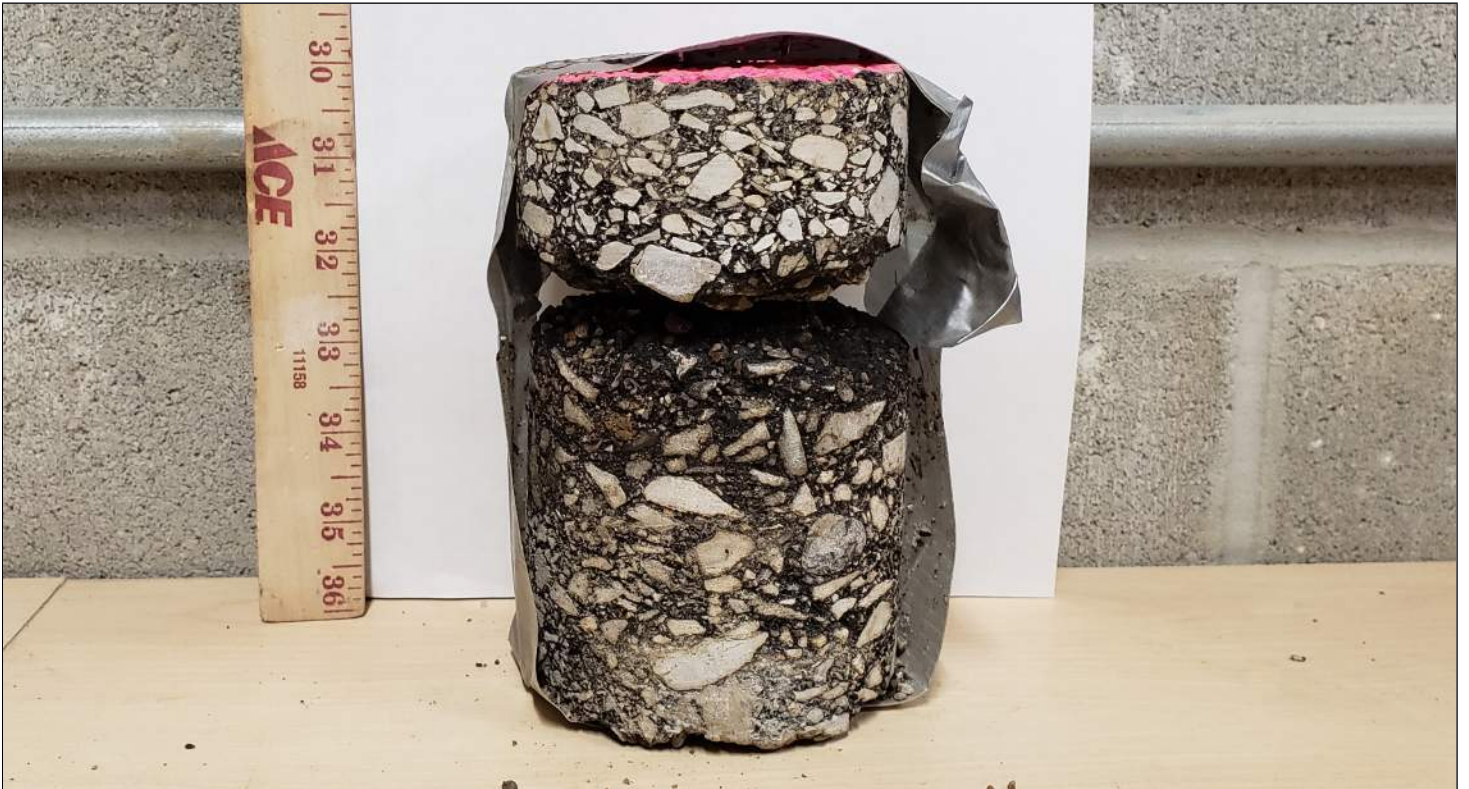
Description: C-15

Pavement cores C15, C17 and C19 indicated asphalt deterioration between the surface course and base courses. Core C16 was completed in a former patched area that appeared competent,

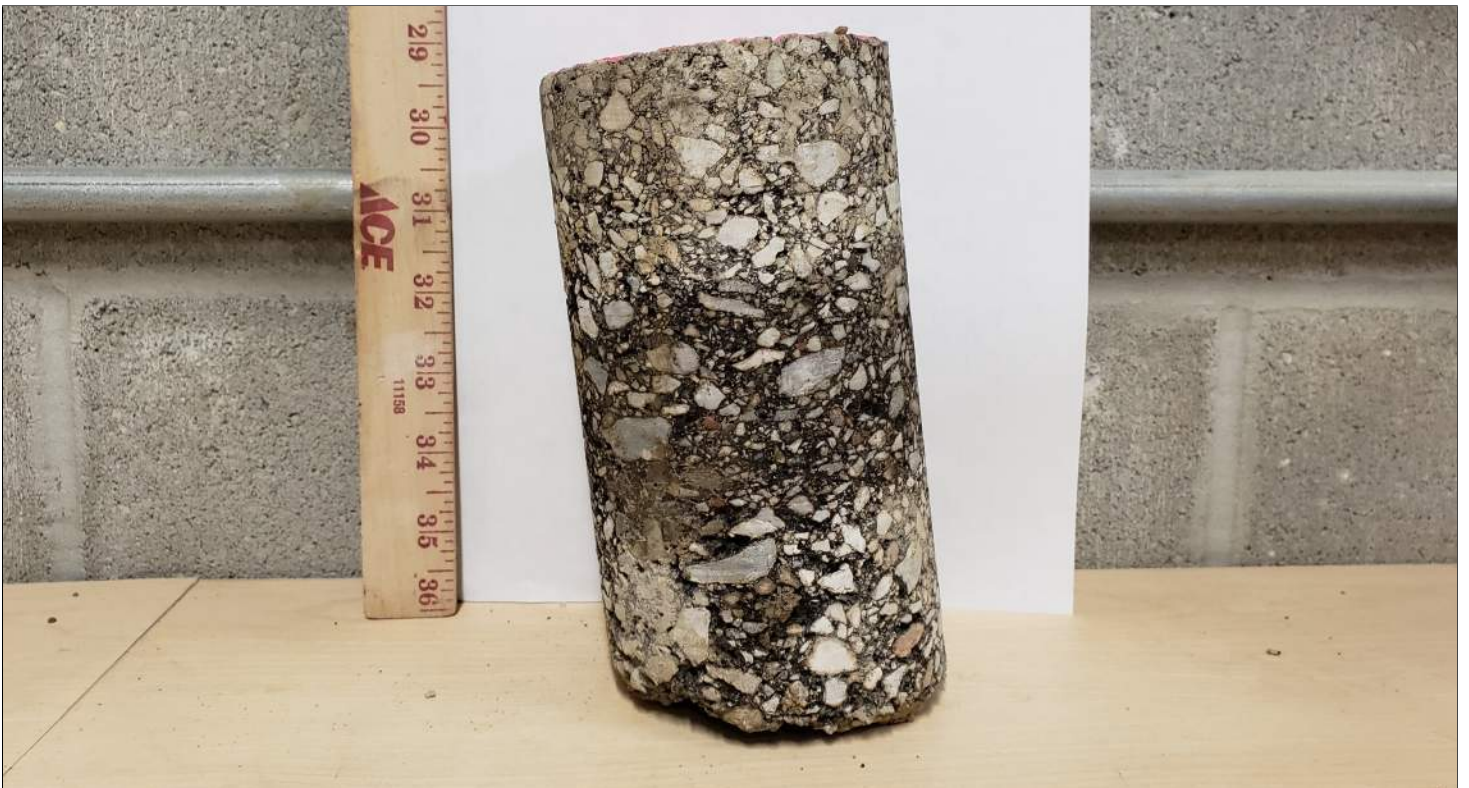
Description: C-16

however it could be assumed that the area around C16 is exhibiting similar pavement conditions as the areas around cores C15 and C17. The recovered cores indicate moisture is becoming trapped within the asphalt pavement layers and the repetitive freeze/thaw action and traffic has increased the rate of pavement deterioration in these areas. It should be noted that these core locations were not all situated in areas of extensive pavement deterioration. Some cores were obtained from areas that appeared to be less disturbed at the surface, but the underlying asphalt quality had been compromised.
